Keawakapu Preliminary Injury Assessment

16 March 2010

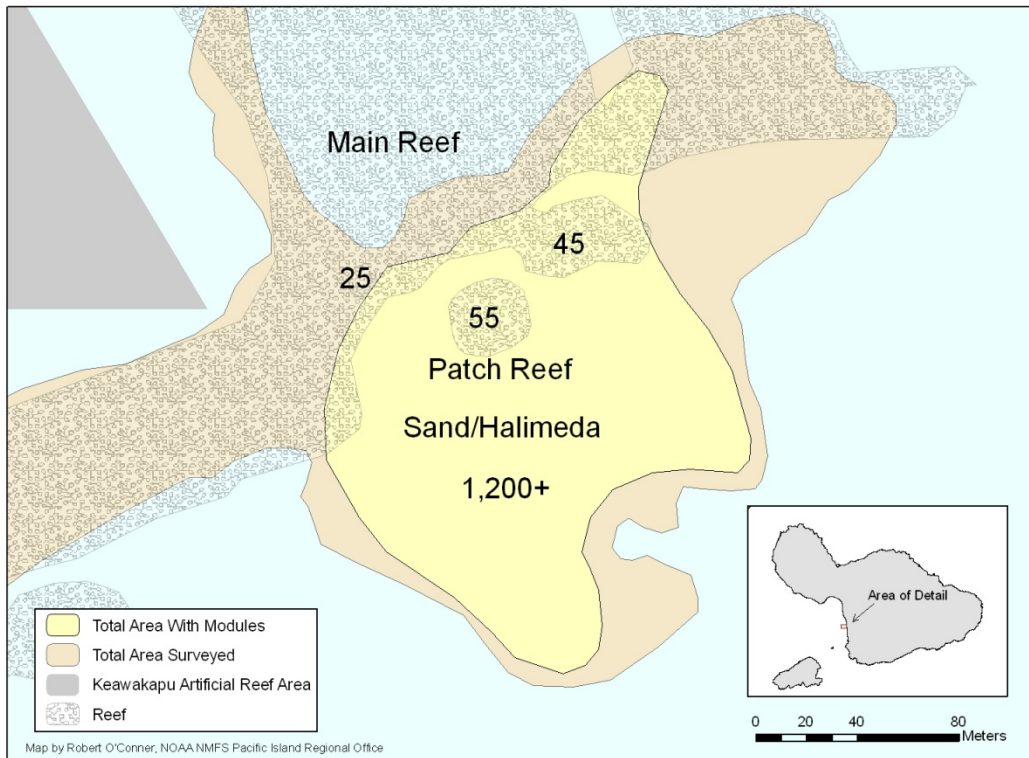
Of the reported 1400 modules deployed, 125 were found to have landed partially or totally on coral reef habitat (Figure 2). All modules that landed on coral reef habitat were of the Z-module form; no hollow cube forms landed on reef. The remaining modules landed on sand or sand with beds of *Halimeda sp.* algae. The total area of the module deployment (including modules that landed on the reef) measured approximately 5 acres (~20,000 m²). The majority of modules did not land on the reef, but dive teams surveyed a larger area to ensure all modules were accounted for. The total area surveyed for injury (estimated from the track logs and spatial maps) was approximately 12 acres (~ 50,000 m²) (Figure 2). During the survey reef injuries from modules were discovered in two habitat areas, a main reef, and an adjacent patch reef. Surrounding these two habitat areas to the south, west, and north was sand and beds of *Halimeda sp.* algae (Figure 2). These areas are discussed in more detail below.

Figure 2. A detail map showing the area surveyed during the three-day pre-assessment project and the spatial extent of the module deployment. The numbers denote the number of modules found on the main reef (25), the extension from the main reef (45), and the patch reef (55). The remainder of the modules (1,200+) was found on sand or sand with *Halimeda sp.* habitat. The southeast corner of the designated Keawakapu Artificial Reef area can be seen on the top left of the map.

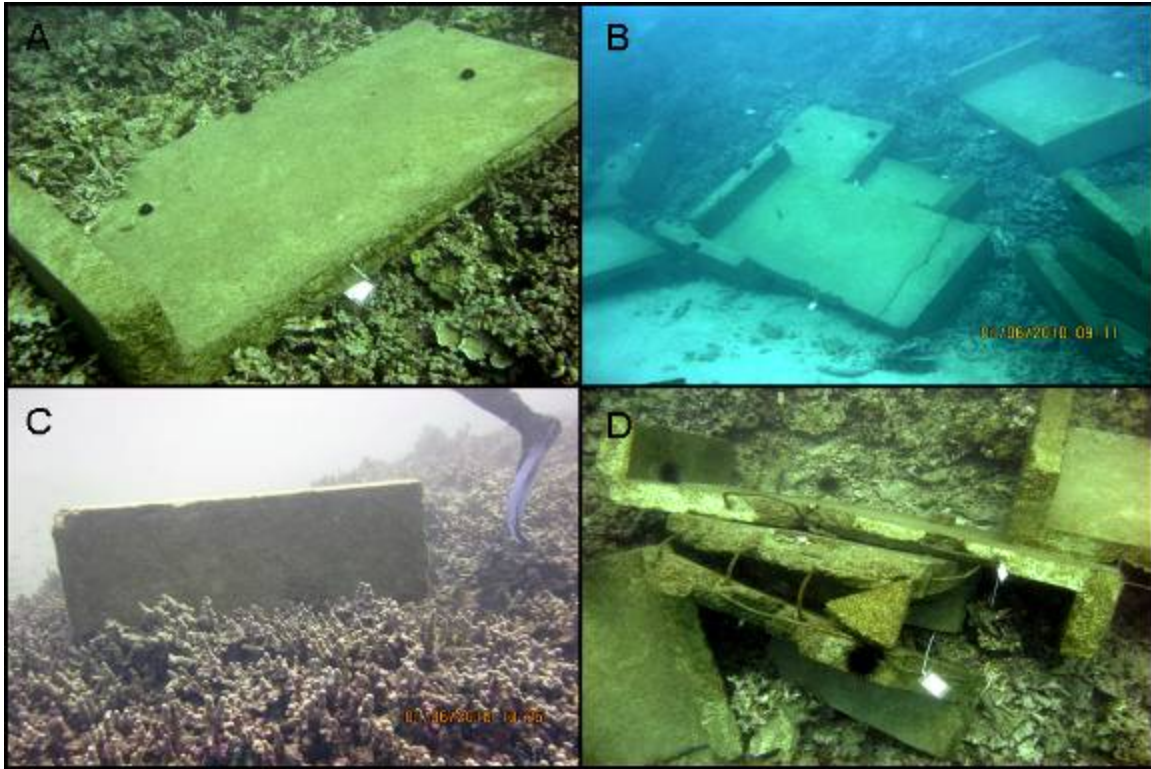
Figure 3. Four representative module orientations found on the reef.

Modules were observed in a wide variety of orientations in all of the habitats. In general the configurations fell into four basic categories: (1) individual modules lying horizontally flat on the substrate (Fig. 3A), (2) several modules stacked together either partially or wholly overlapping each other (Fig. 3B), (3) modules lying partially or fully on edge (Fig. 3C), (4) fragmented and damaged modules (Fig. 3D).

A) An individual solitary module lying flat along one face.

B) A cluster of modules overlapping each other with some modules lying partially in sand.

C) An individual module lying upright along its long axis.

D) A cluster of modules showing signs of substantial collision with the reef (modules are fragmented and broken). A perimeter of broken coral can be seen surrounding the cluster indicating that the modules slid after impact.

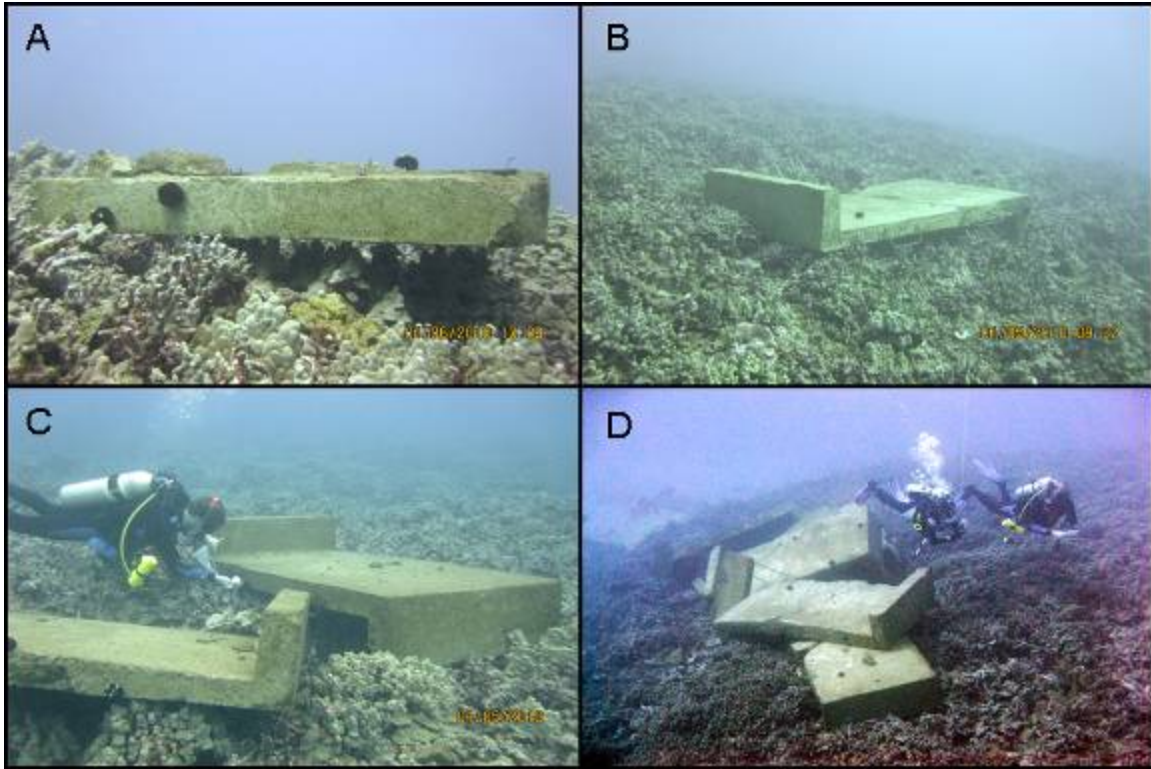
Figure 4. Modules found on the main reef area.

The main reef in the survey area is part of a reef complex extending to the north and east (Figure 2). The section of main reef surveyed for injury was a ridge approximately 300 ft (~ 100m) wide (north/south) and at least 1500 ft (~ 500 m) long (east/west). The top of the main reef was in approximately 50 ft (~ 17 m) of water with the north side of the ridge sloping to > 100 ft (~ 33 m) and the south edge sloping to approximately 70 ft (~ 23 m). Twenty-five modules were concentrated in a central portion of the main reef on the southern edge of the area surveyed (Figure 2). The condition of the modules in this area varied. Some modules were undamaged and appeared to have impacted the bottom with relatively little physical force (Fig. 4A), but others were damaged, suggesting a greater

impact force with the bottom (Fig. 4B, 4C). Most modules in this area of reef were solitary or in pairs, but a few small clusters of modules were observed (Fig. 2D). The density of modules found in this area was low.

A) An individual module that appears to have settled on the reef without breaking all the coral underneath it. Intact coral can clearly be seen underneath the module, supporting its weight. Shading under the module is evident in the photo and will likely result in some coral mortality.

B) A solitary individual module showing a crack across the top indicating that it may have settled with substantial force.

C) A pair of modules on the main reef that was representative of the typical density of the modules in this area. Note intact coral can be seen under the module in the foreground.

D) A cluster of cracked and broken modules that was atypical of the density of modules in the main reef area.

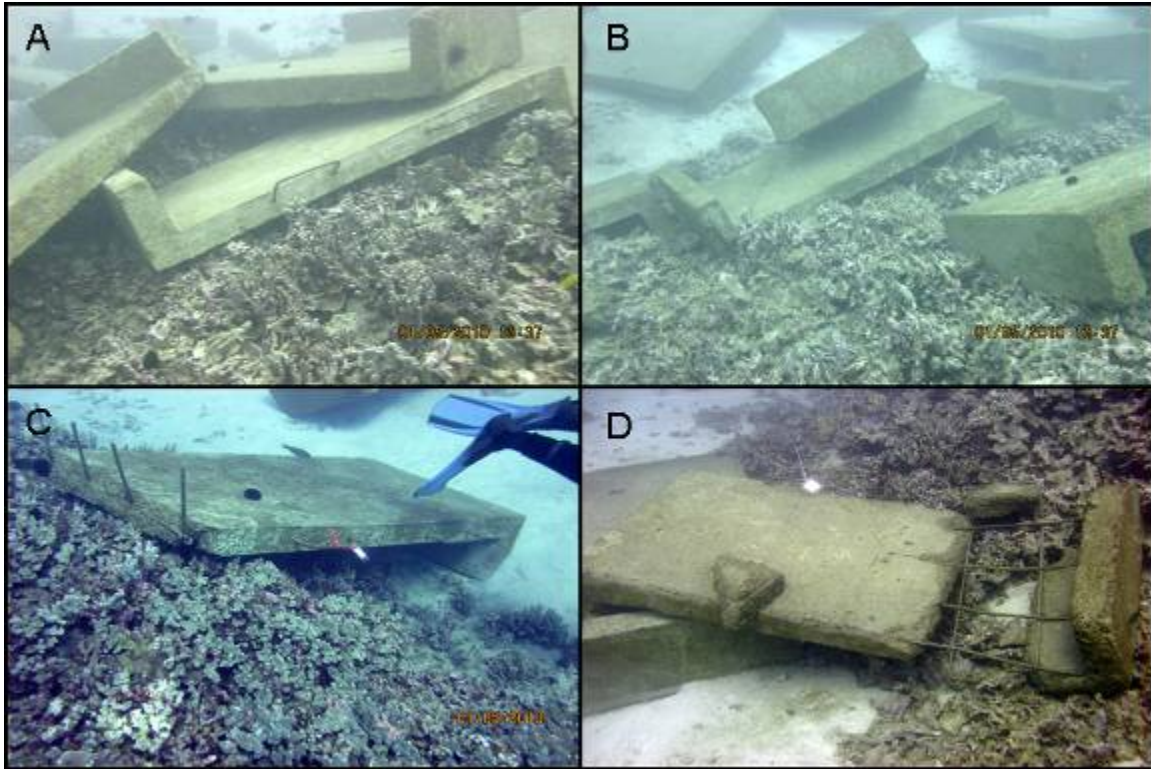
Figure 5. Modules found on the extension of the main reef.

An extension of the main reef was impacted by 45 modules with the majority of modules located along the southern edge (Figure 2). This oblong extension of reef was located on the eastern section of the surveyed area of main reef. This portion of reef was attached to the main reef at approximately 50 ft (~17 m) depth, extending southeast and sloping to the sand bottom at 70 ft (~23 m). The density of the modules on this extension was greater than that found on the main section of reef, and modules were frequently observed in overlapping clusters (Fig. 5A, 5B). Some modules were also clustered along the southern margin of the reef protrusion lying partly on sand, and several showed indications of substantial collision force with the substrate (Fig. 5C, 5D).

A) An overlapping cluster of modules on the extension of the main reef. Broken coral can be seen in a perimeter around the modules indicating that they slid down slope causing additional injury to coral.

B) A typical overlapping cluster of modules on the reef perimeter showing evidence of sliding.

C) A module lying partially on reef and partially in sand. The edge of the module has been broken off exposing the internal rebar structure.

D) Overlapping modules lying partially in sand. The top module has been broken exposing the internal rebar framework. Module fragments can be seen nearby.

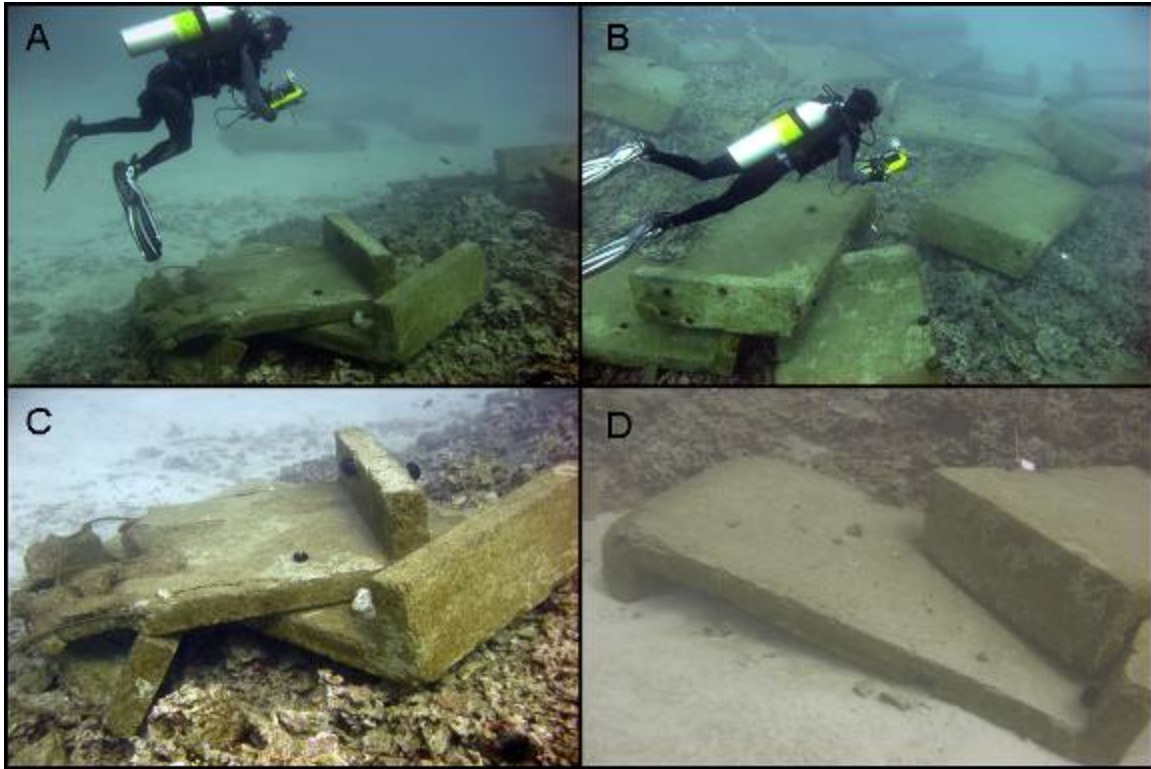
Figure 6. Modules found on the patch reef.

Modules were also observed on a patch reef just south of the main reef (Figure 2). The patch reef was approximately 150 ft (~ 50 m) in diameter with the top at 50 ft (~ 17 m) depth and sloping to the sand bottom at 70 ft (~ 23 m). Fifty-five modules were clustered on the patch reef (Fig. 4A, 4B). Modules were observed across most of the patch reef. Many of the modules appeared to have experienced substantial collisions with the substrate and appeared to have slid down the reef slope causing additional damage to coral (Fig. 6C). Some modules lay partially in the sand at the reef/sand margin around the perimeter of the patch reef (Fig. 6D). Most of the hollow cube modules were found isolated and in clustered formation to the east and south of the patch reef.

A) Overlapping modules on coral.

B) A representative photo showing the density of modules on the patch reef. Of all the reef areas surveyed, the density of modules was highest on the patch reef.

C) An overlapping cluster of modules showing signs of substantial collision with the reef. The modules are broken and a perimeter of injured coral can be seen surrounding the modules indicating that they slid down slope.

D) An overlapping cluster of modules along the reef/sand margin of the patch reef. The modules are lying partially in sand and partially on reef.

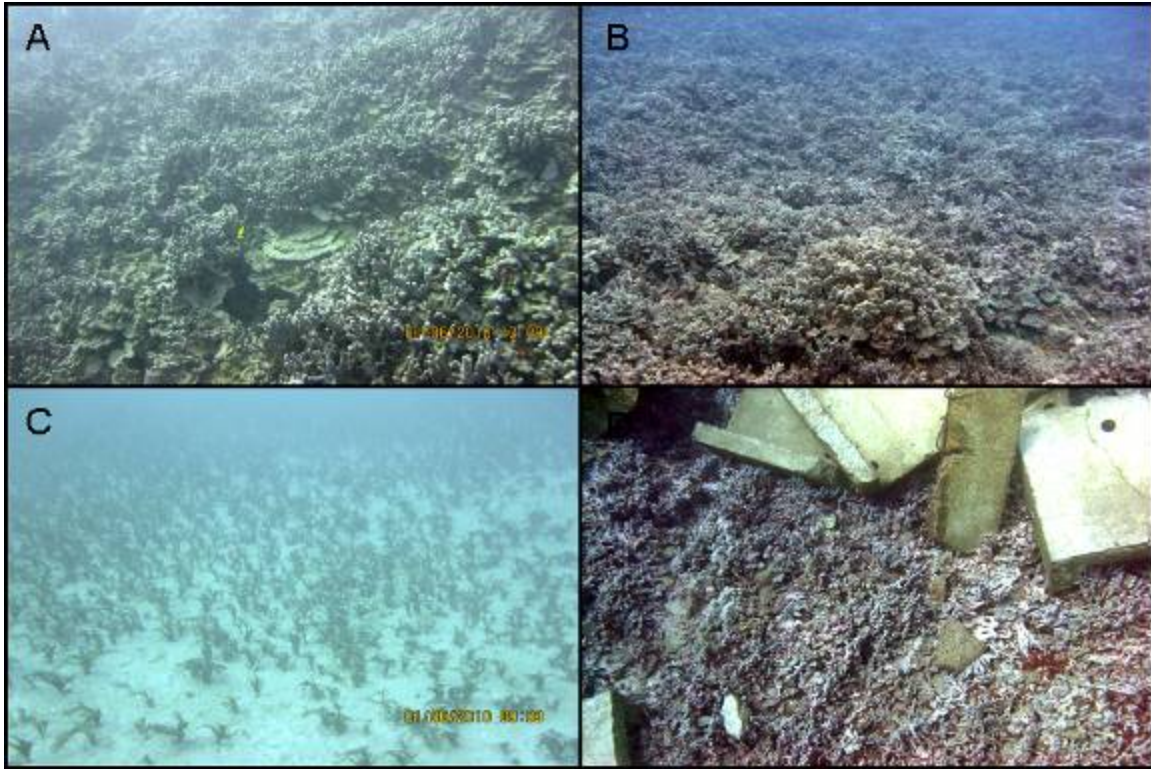
Figure 7. Representative photographs of the habitats and species in the area.

Coral cover was high (> 50%), and relatively homogenous across the main and patch reef sections. The coral community was predominantly composed of *Porites compressa*, encrusting and finger-like morphotypes of *Porites lobata*, and encrusting *Montipora capitata* (Fig. 7A, 7B). Colonies of *Montipora patula*, *Pocillopora meandrina*, *Pocillopora damicornis*, and *Pavona varians* were also observed. No larger coral colony mounds were noted and there appeared to be substantial coral fission which made identifying discrete colonies difficult. Broken pieces of *P. compressa* were observed in areas where modules had landed and then shifted and also where module fragments had rolled down slope (Fig. 1D, 5A, 5B, 6C). There was a limited abundance of reef cementing crustose coralline algae.

A) The reef showing several species and relative coral cover typical of all surveyed areas.

B) The reef showing several species and relative coral cover typical of all surveyed areas.

C) Sand bottom habitat with *Halimeda* sp. beds. This habitat surrounded the reef areas and contained the majority of deployed modules.

D) Fragments of broken *Porities compressa* coral seen commonly in most injured areas.
